**Home Inspection Report**

**123 Generic St  
Milwaukee, WI 53224**

**House Detective  
Property Inspection Services  
New Berlin, WI 53151**

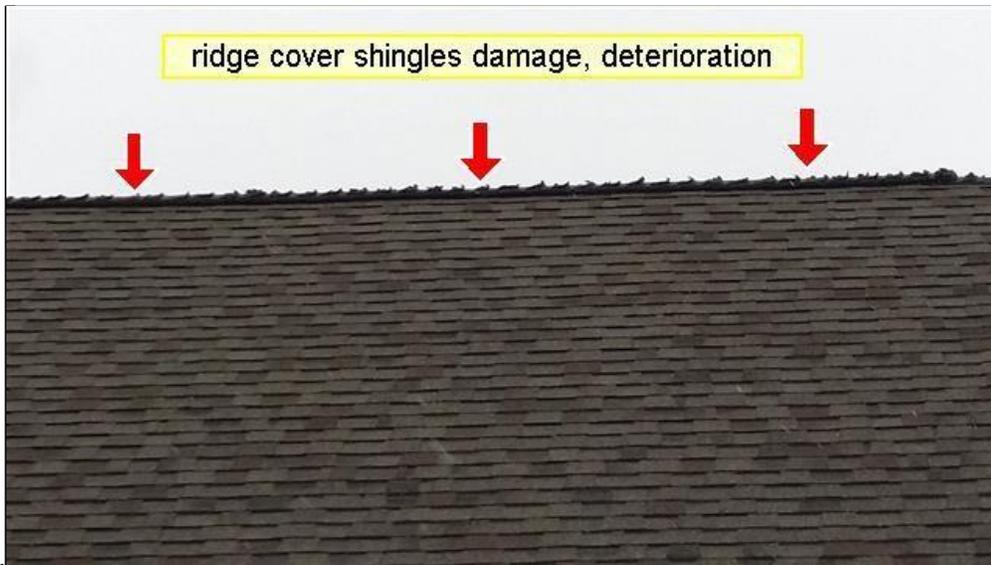
#### 1.1 Pitched Shingle Coverings

One or more areas have significant wear, deterioration, and damage, exposed felt, exposed nail heads, lifting or granular loss. One or more areas are lifted, missing or damaged. The cause is not determined. Recommend evaluation and repair by a qualified contractor.

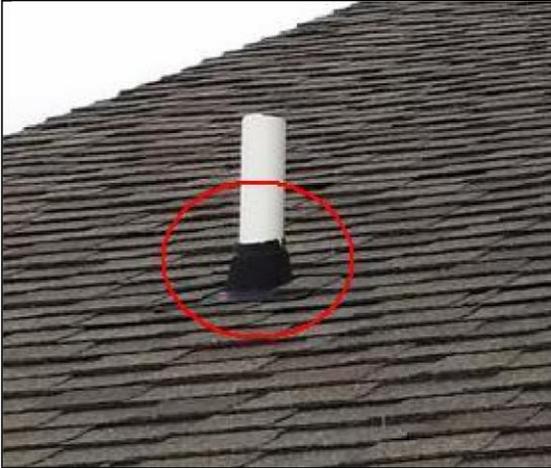
**1.9 Plumbing Vent Pipes**

One or more pipe boot flashings are damaged. Recommend evaluation and repair by a qualified contractor.

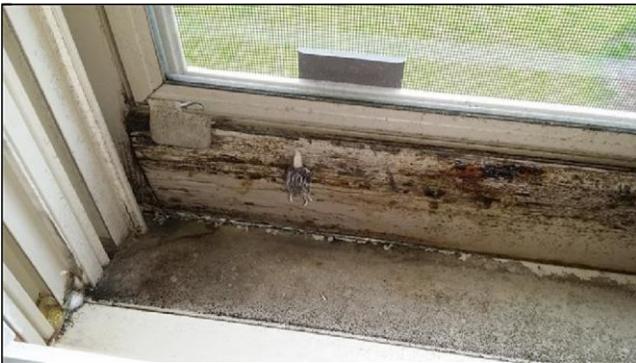
### 2.3 Windows (representative no.)

One or more storm windows are broken, cracked, damaged or have significant deterioration. Recommend evaluation and repair by a qualified contractor.

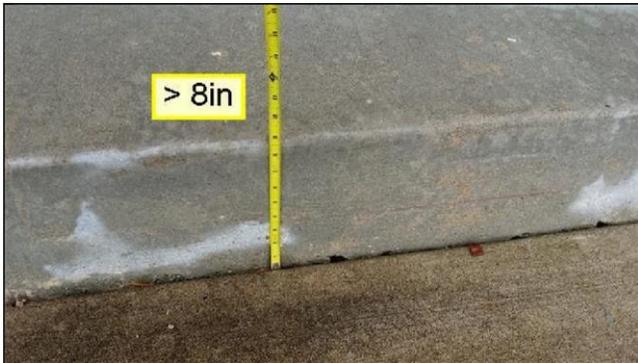
#### 3.0 Driveways / Walks / Patios

There is walk settlement that is causing the step height to be greater than 8in. Recommend evaluation and repair by a qualified contractor. Reconstruction may be necessary.

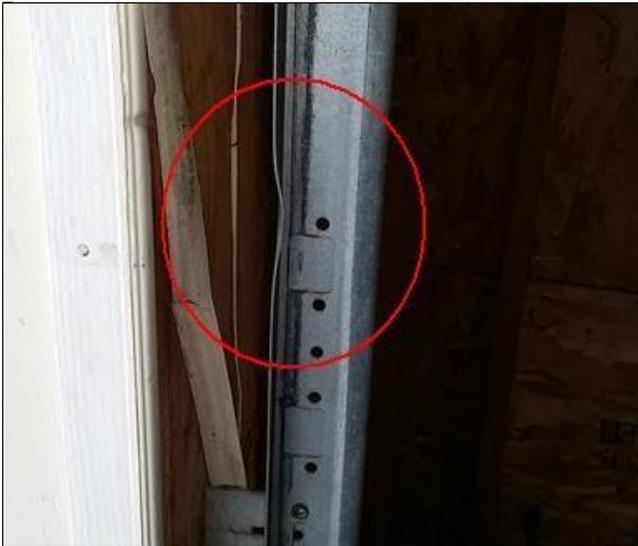
#### 5.0 Vehicle Doors

One or more door tracks are damaged. Recommend evaluation and repair by a qualified contractor.

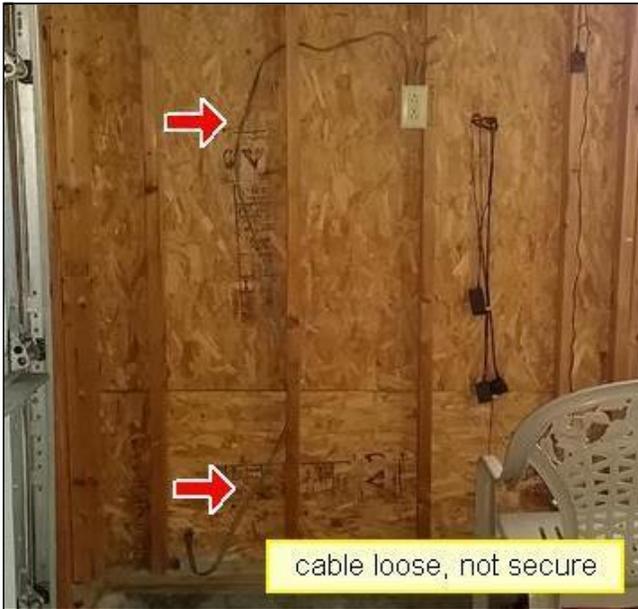
**5.4 Conduit / Cable**

There are one or more damaged, improperly installed, supported or routed cables/conduits present. Recommend evaluation and repair by a qualified contractor.

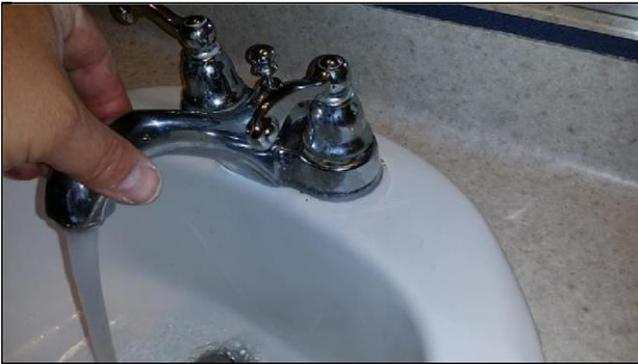
**7.5 Sink Faucets****Comments:** Defect

One or more faucets are loose and need to be properly tightened (upstairs hall). Recommend evaluation and repair by a qualified contractor.

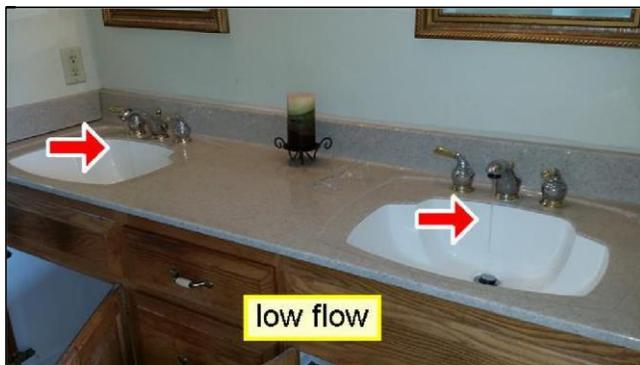
One or more faucets have significant reduced flow on hot and/or cold. The cause is not determined. Recommend evaluation and repair by a qualified contractor.

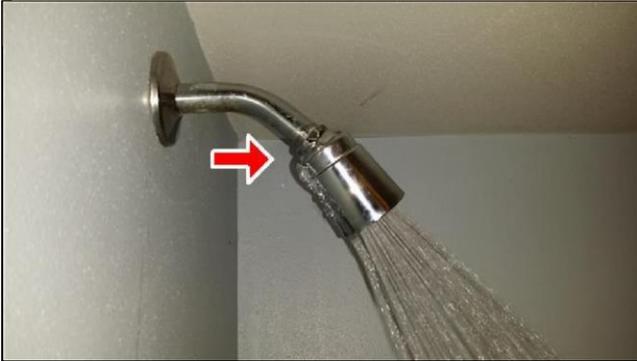
**7.15 Tub / Shower Heads**

One or more shower heads are leaking. Recommend evaluation and repair by a qualified contractor.

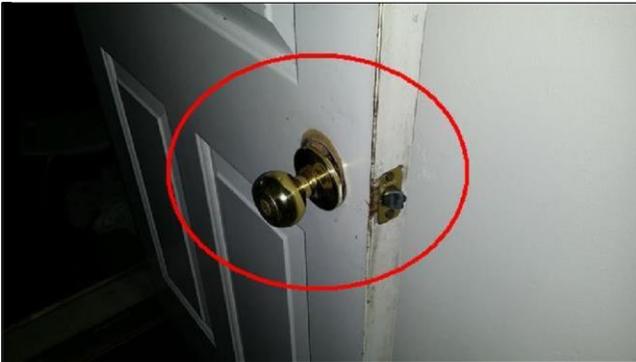
### 8.0 Entry Doors

One or more door knobs and/or associated hardware are loose, damaged, stick or do not function properly. Recommend evaluation and repair by a qualified contractor.

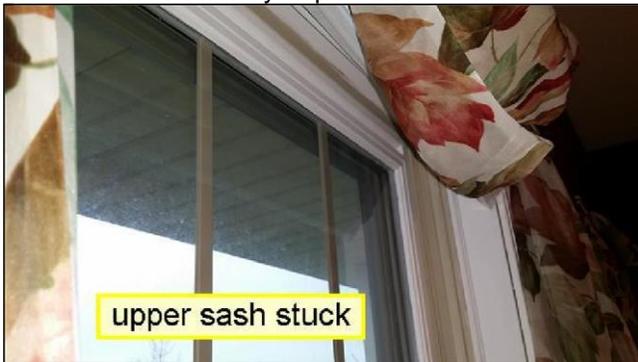
One or more windows stick or do not open/close properly. Recommend evaluation and repair by a qualified contractor.

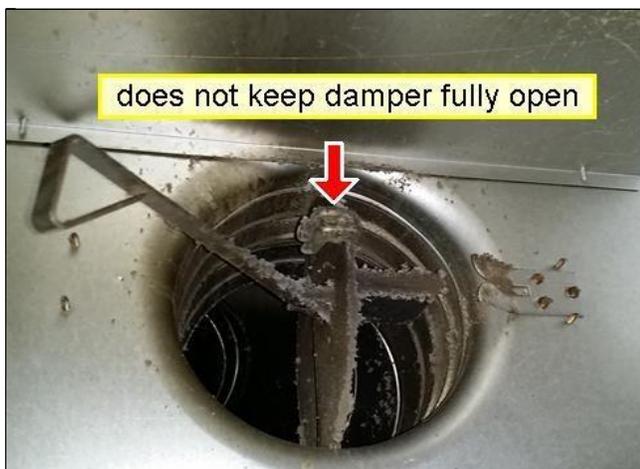
### 9.3 Damper Door Function

The damper clamp is not keeping the damper fully open. Some jurisdictions require dampers be permanently open for gas fireplace logs. The reason for this is that using the gas logs with the damper closed would put deadly carbon monoxide in the house. Damper clamps (also referred to as damper stops, damper locks or damper flue clamps) are typically a small C-clamp or steel beam clamp. The damper clamp is designed to lock the damper in a fully-open position. Recommend evaluation and repair by a qualified contractor.

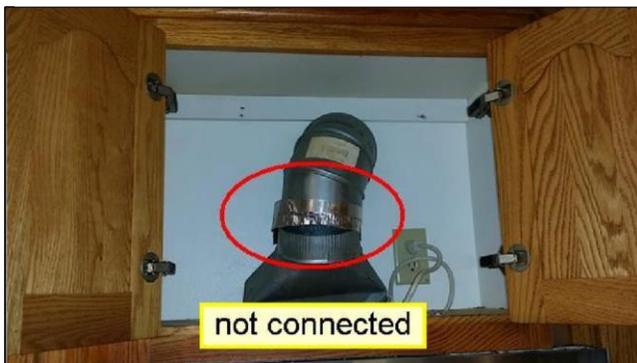
#### 10.2 Exhaust Fans

The exhaust duct work is damaged, not connected or not connected properly. Recommend evaluation and repair by a qualified contractor.

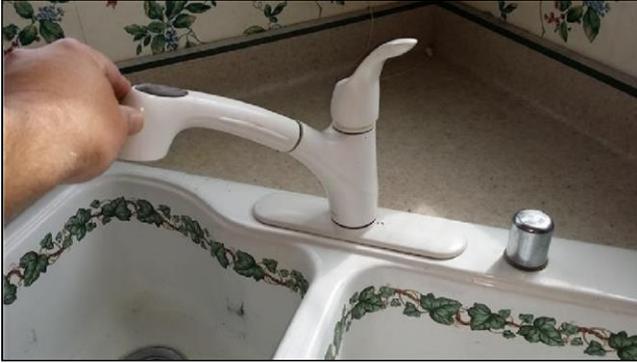
**10.4 Sink Faucets****Comments:** Defect

One or more faucets handles are loose and/or damaged. One or more faucet spouts are tight moving side to side. This could be from improper installation and/or some kind of damage. Recommend evaluation and repair by a qualified contractor.

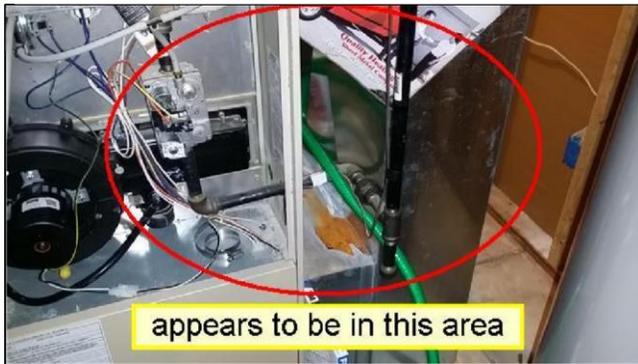
**12.5 Fuel Supply Piping****Comments:** Defect

One or more gas supply pipes may be leaking. Recommend evaluation and repair by a qualified plumbing contractor.

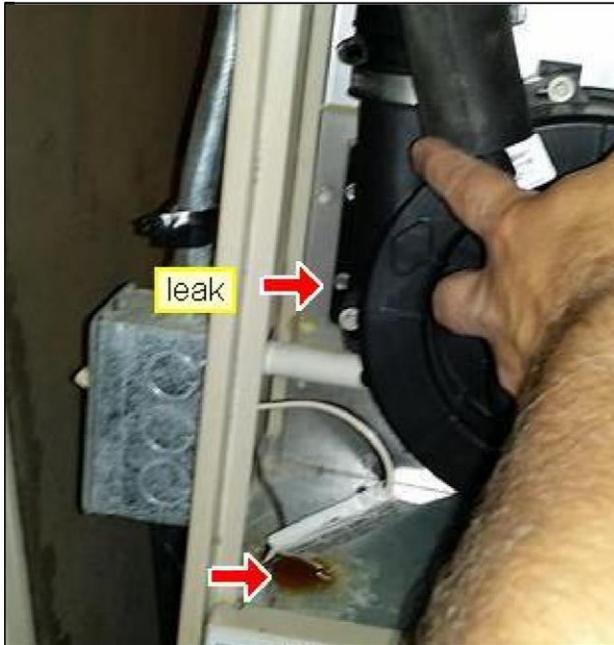
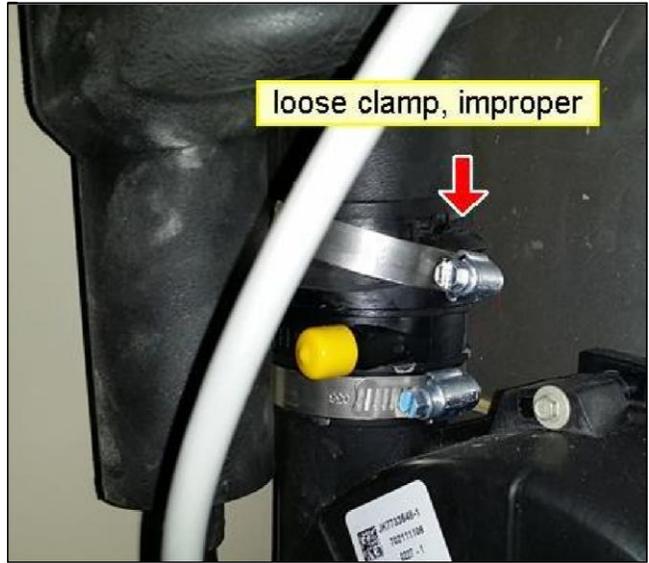
12.12 Exhausts / Intakes / Damper

The intake is leaking or has condensation that is coming into the cabinet. Recommend evaluation and repair by a qualified contractor.

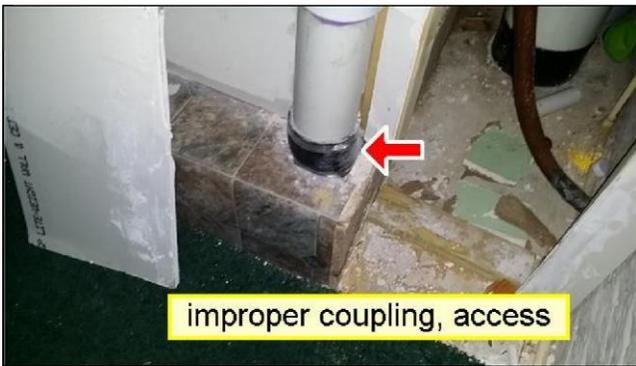
**13.4 Main DWV Pipes**

One or more pipes are in a non-standard configuration and are improper. Recommend evaluation and repair by a qualified plumbing contractor.

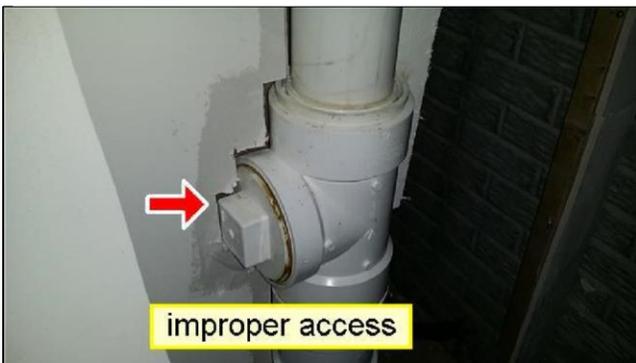
**13.5 DWV Clean Out(s)**

One or more clean out covers are not accessible. Remove the obstruction or move the cleanout. Recommend evaluation and repair by a qualified contractor.

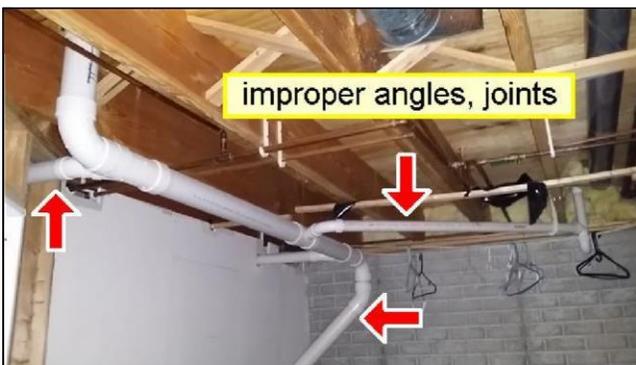
**13.6 DWV Pipes**

One or more pipes are in a non-standard configuration and are improper. Recommend evaluation and repair by a qualified plumbing contractor.

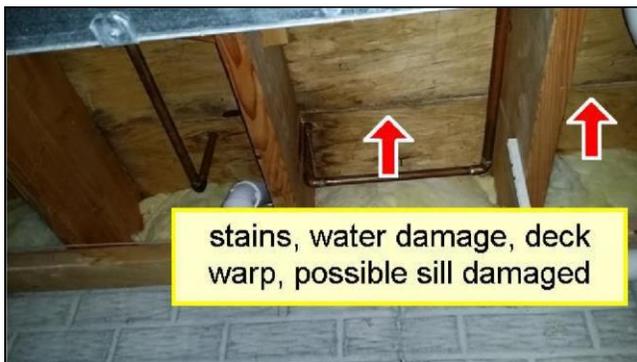
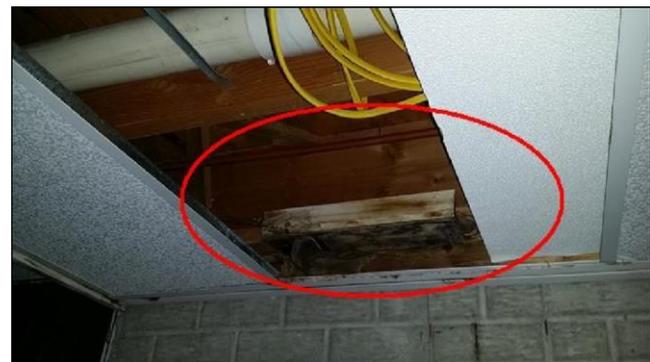
#### 15.1 Sub Floor Structure

There is water damage present on the floor structure and/or sub-floor. Significant damage or weakening has occurred. Recommend evaluation and repair by a qualified contractor.

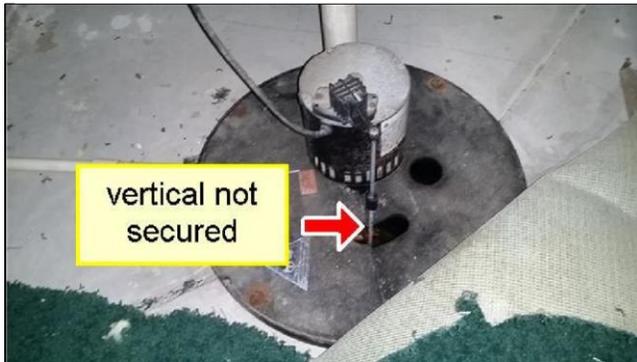
### 15.4 Foundation Drainage System

The pump float rod is interfering with the lid and could jam. This could lead to a potentially serious water intrusion issue. Recommend evaluation and repair by a qualified contractor.

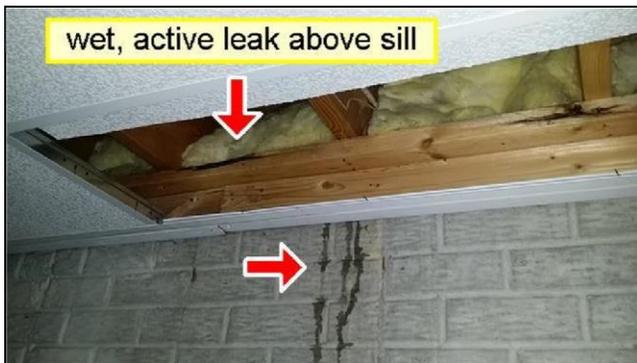
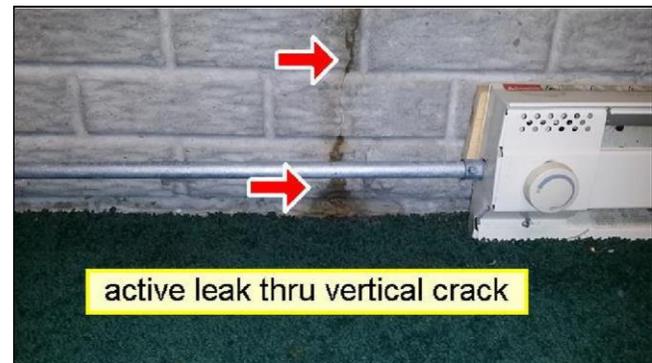
### 15.5 Water Intrusion / Penetration

There is efflorescence, damp areas, heavy staining, deterioration or active water intrusion present. The cause is not determined. Water intrusion can be caused by problems with the foundation drainage system, roof drainage and grading. Recommend evaluation by a foundation inspection consultant (an independent inspector with no contractor affiliation). If drain tiles are present the evaluation should include a drain tile test to determine exactly how the foundation drainage system is functioning. Drain tile testing typically involves creating holes in the basement floor, and must be approved by the seller. Significant repair or reconstruction may be necessary.

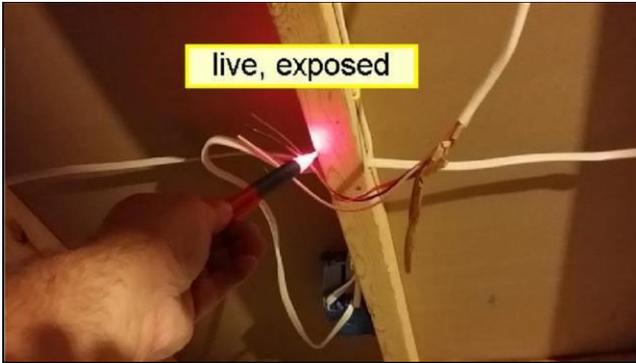
**16.8 Unfinished Conduit / Cable**

There are one or more exposed cable/conduit wires present. Recommend evaluation and repair by a qualified contractor.

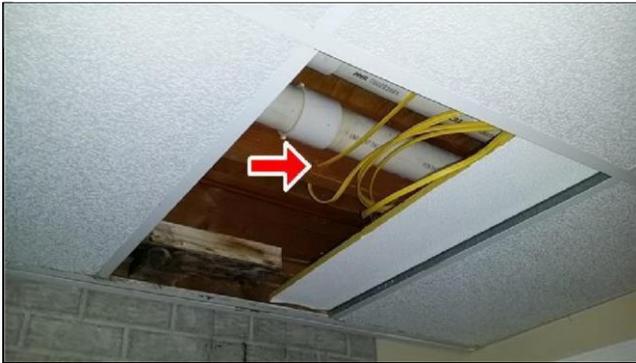
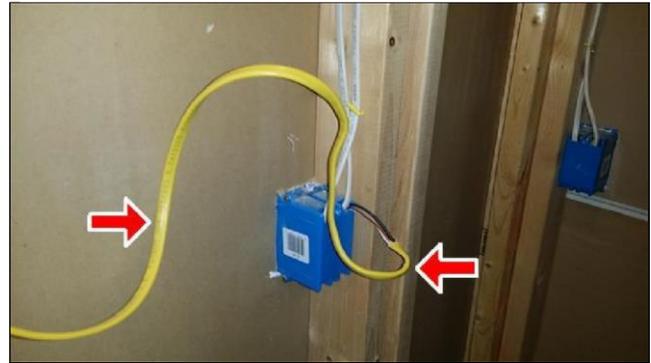
There are one or more improperly installed, supported or routed cables/conduits present. Recommend evaluation and repair by a qualified contractor.

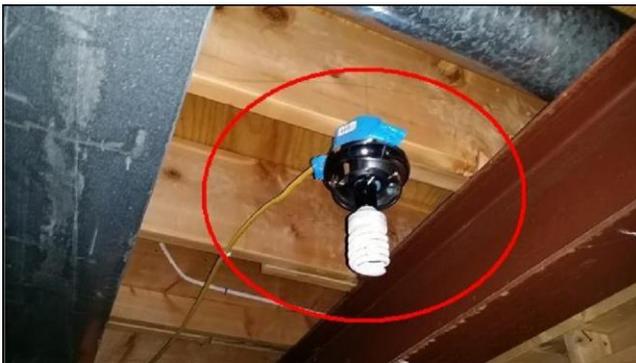
**16.9 Unfinished Receptacles / Switches / Lights**

There are one or more lights that are damaged, improperly installed, not functioning or not functioning properly. Recommend evaluation and repair by a qualified contractor.
